**RECOMMENDATIONS FOR REPAIR OF
SPRAY POLYURETHANE FOAM (SPF) ROOF
SYSTEMS DUE TO
HAIL AND WIND DRIVEN DAMAGE**

**RECOMMENDED
DESIGN CONSIDERATIONS
AND GUIDE SPECIFICATIONS**

**Spray Polyurethane Foam Alliance
Copyright January 2003**

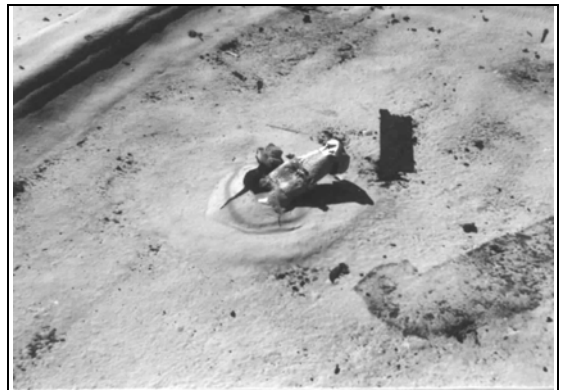
During high wind events a wide variety of objects can potentially impact a roof and produce damage to the protective coating and SPF. This damage may be isolated to small areas of the roof or cover large areas. Substrate and structural damage may or may not have occurred and should be thoroughly investigated. The type of repairs required will depend on the size and severity of

the damage and should be consistent with SPFA's Guideline AY-122, "The Renewal of Spray Polyurethane Foam and Coating Roof Systems."

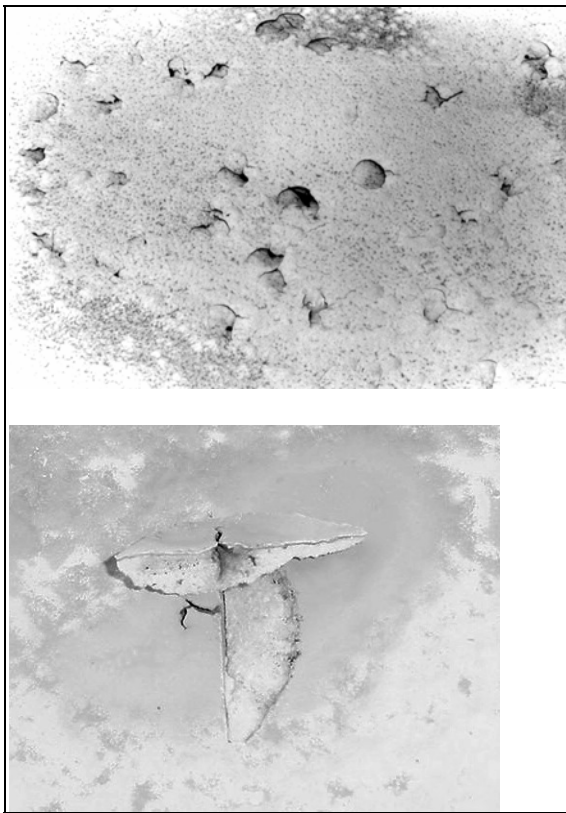
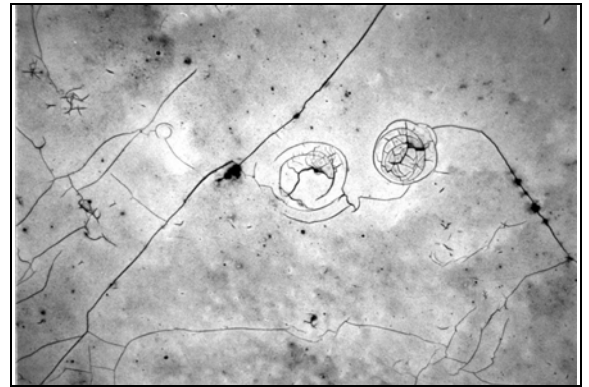
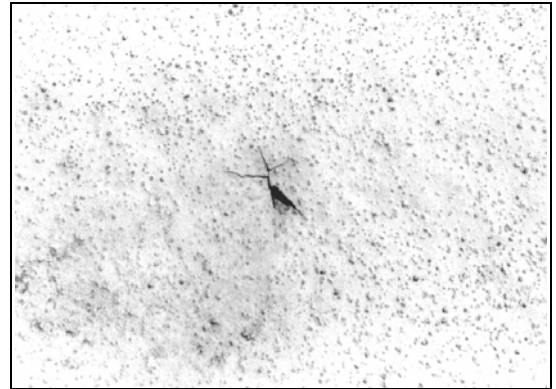
Coating damage can appear as gouges, cracks, and punctures. Hail induced coating cracks often form patterns shaped like “crow’s feet” or semi-circles.

Depending on hail stone size, shape, and hardness, the underlying foam may be dented, cracked, or gouged. Depressions in SPF dented by hail stones may be 1/8-inch to 3/4-inch deep. Hail damage can be isolated to small areas or cover the entire roof surface.

The repair technique is determined from the severity (size and depth of damage) and extent (number of hail hits per unit area) of the hail damage. For example, fifteen 3-inch diameter hail dents on a 1000 square foot roof may be easier to repair than hundreds of 3/4-inch diameter dents.
