## Case Study- hard coat spray with Graco HFR machine

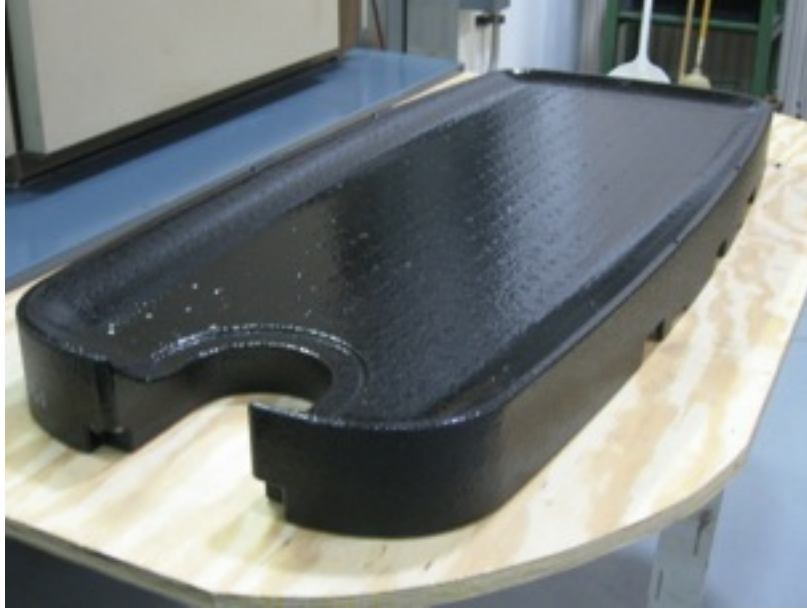
**Problem:** A large composite tub manufacturer was experiencing breakage on an expanded polystyrene (EPS) tub base support. The design was already tooled and approved so a quick fix had to be found.

**Solution:** Working with the EPS supplier and a local urethane molding house, NCFI Polyurethanes developed a black “hard coat” spray elastomer that significantly increased the strength properties without adding excessive weight or increasing part thickness beyond specifications. A Graco HFR plural component metering unit with a Fusion air purge gun was installed to efficiently spray the material. The molding house designed a robotically controlled process that allowed them to coat a base approximately every ninety seconds with remarkable repeatability and accuracy.
