# Erosion Threatens Parking Structure in Posh Downtown Dallas. Contractor Uses TerraThane™ to Save the Structure and the Owner Millions of Dollars.

## NCFI TRENCH BREAK FOAM SYSTEM 24-023

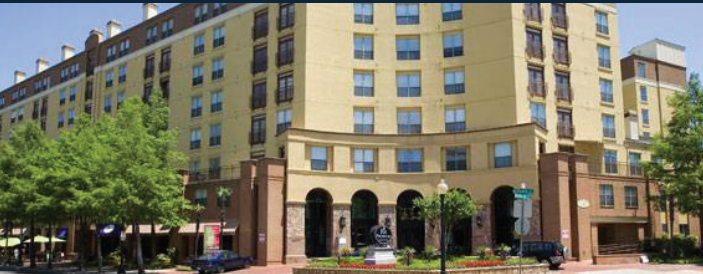
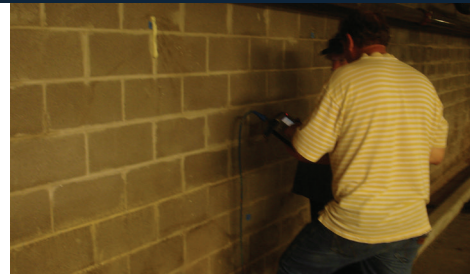
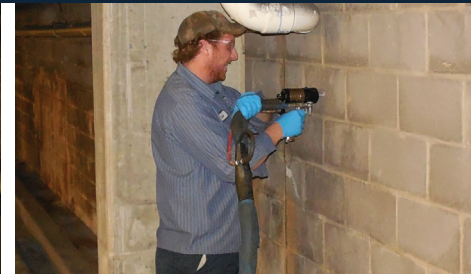
Erosion around a three-story, in-ground parking garage in Dallas' "Uptown" area and home to some of the city's posh apartments, business addresses, shopping, hotels, restaurants and bars, created a large void in the soil surrounding the piers and gave the developer serious headaches.

- + Drilled a shaft down along the piers and soldier piles and lagging, to survey the problem and found the water had gone through the block wall and carved out what appeared to be a five-foot cavity.
- + Chose NCFI's TerraThane™ geotechnical foam
- + Used boroscope, ground-penetrating radar, to help determine the overall void and cavity dimensions
- + Ran a 3/8-inch vinyl tube behind the block and dropped in the TerraThane™ polyurethane foam

Edens says, "TerraThane™ gives us four products in one." It fills in large and small voids running both vertical and horizontal in the cavity, serves as a water and air barrier so it will impede future water and silt infiltration, it's amazingly strong, and it's light, so it won't add any weight to the block wall. We were in and out in two months with minimal disruption of the parking. The
